CABOOLTURE AERO CLUB

SAFETY NOTICE TO MEMBERS

2/24

TAXIWAY A - WEIGHT RESTRICTION

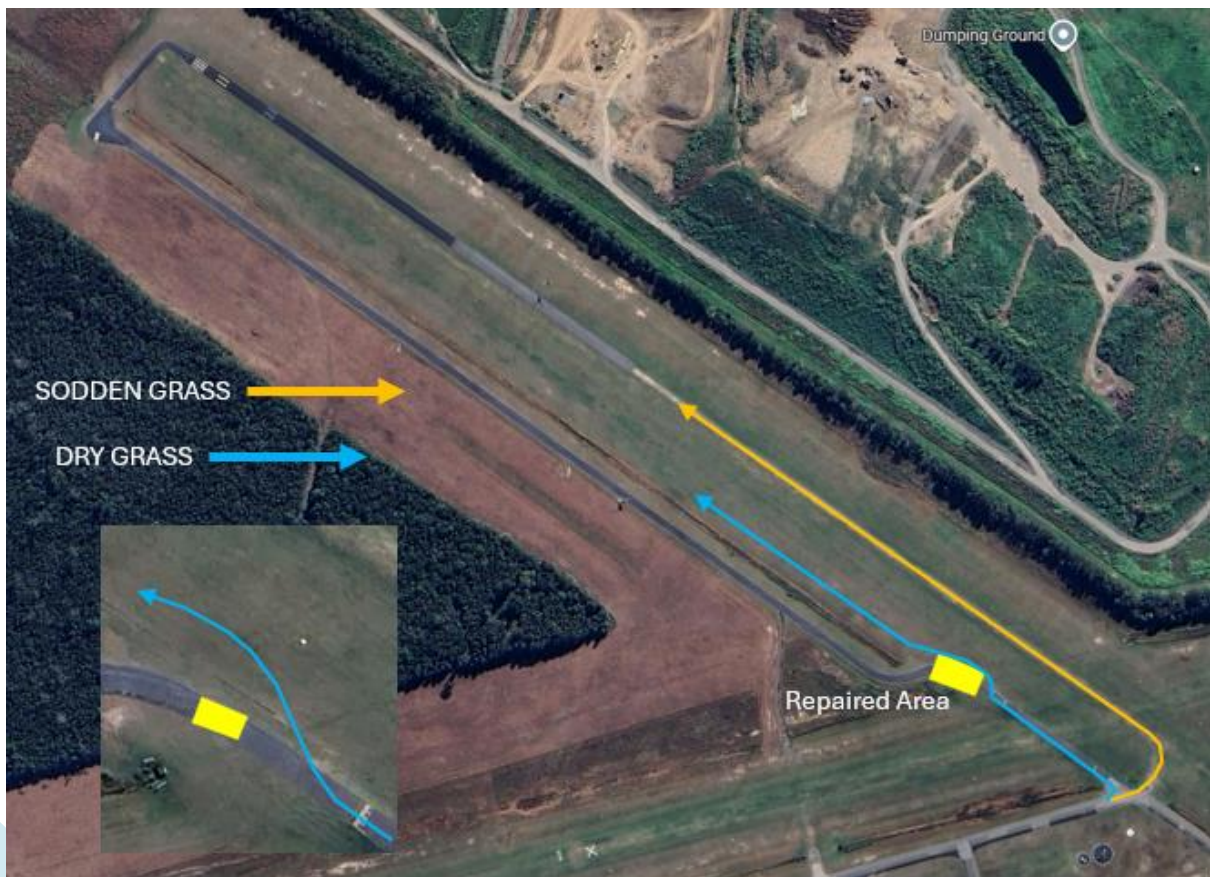
Our hardworking volunteer repair crew have performed temporary repairs to both Runway 11/29 to address pooling near the centreline and also repairs to the recently damaged taxiway NW of the 06/24 crossing. Due to the condition of the taxiway until a permanent repair is performed, or until further notice, there will be a weight limit applied to this hard surface.

Aircraft greater than 2000Kg MTOW are required to taxi to RWY 11 avoiding the repaired section and use the grass between the gable markers and drainage ditch. Pilots are also required to exercise good judgement about using the grassed areas between the gable markers and drainage ditch while the ground is wet. Where the grassed areas may be too soft, pilots should enter and backtrack on the runway centreline, exercising good lookout and airmanship by communicating clear intentions. Other pilots airborne are requested to also exercise good airmanship and where possible, adjust flight-path to work with the backtracking aircraft.
